Manhole Inspection Summary

Manhole # S21GG_040MH

Insp Date: **6/26/09 10:41 AM**

Location Address: **1605 FULTON AVE**

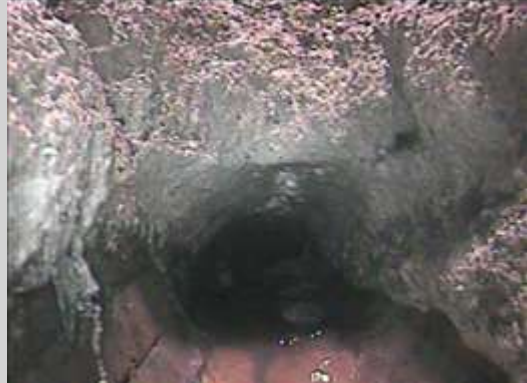
6 O'Clock Inflow

10 in. Circular Gravity Sewer

Pipe In @ 6 O'Clock

Deposits: ☒ None ☐ Mud ☐ Sludge ☐ Debris ☐ Grease

Infiltration: **None** Pipe Seal Cond: **Sound**

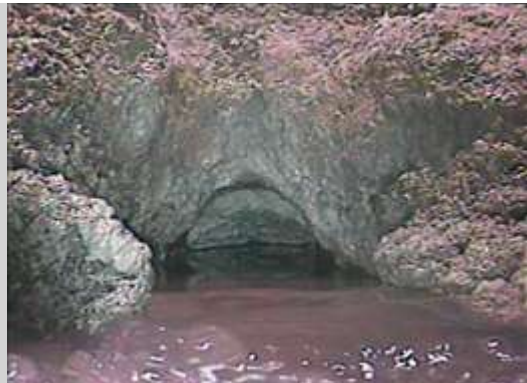
9 O'Clock Inflow

8 in. Circular Gravity Sewer

Pipe In @ 9 O'Clock

Infiltration: **None** Pipe Seal Cond: **Sound**
